## Case Projects

# Jimmys Creek VIC

## Retrofit of CWT Collection Well System

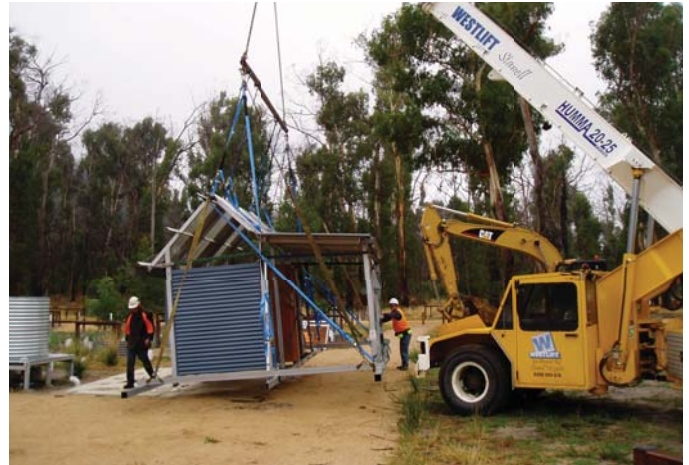
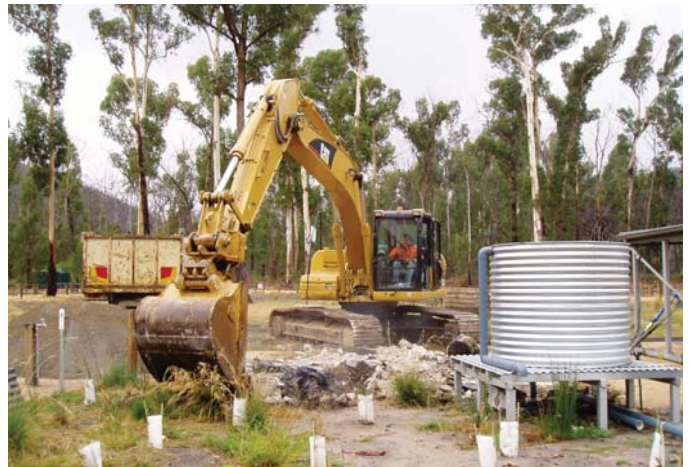
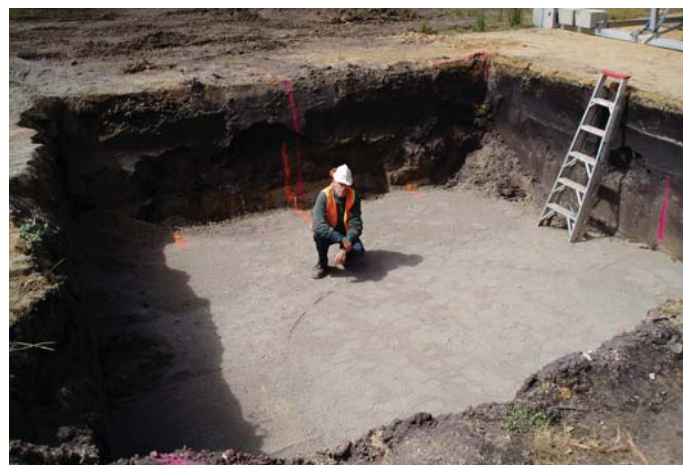
The collection well, footing columns and precast floor were then placed by crane. A ground anchor system ensured the collection well would not float once the ground water established itself at its former level.

The building was now positioned and masonry anchored. Pureblue stainless steel pedestals were now fastened to the ports cast in the concrete floor. Backfilling and resurfacing of the surrounding circulation space with washed gravel completed the project.

On site, the building was rigged. Multiple adjustable lifting straps had to be used to ensure the building did not distort and fail in the lifting process. The building had to be braced with similar straps in every plane. Once the masonry anchors were removed, the building lifted off easily using a Franna type crane.

Now the demolition, excavation and pad preparation was done. The client required that the refurbished building had a similar RL for the concrete floor as the old building, and as close as possible to the original building's position. This required accurate site survey, marking and pad preparation.
