# Kambah Rock Pools ACT

## Retrofit of CWT Collection Well System

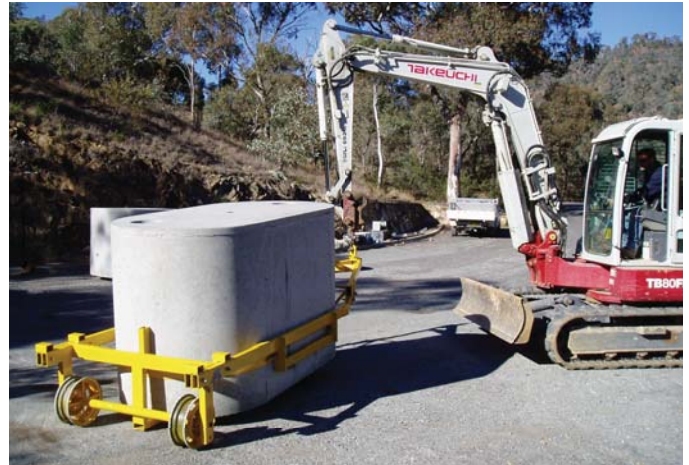
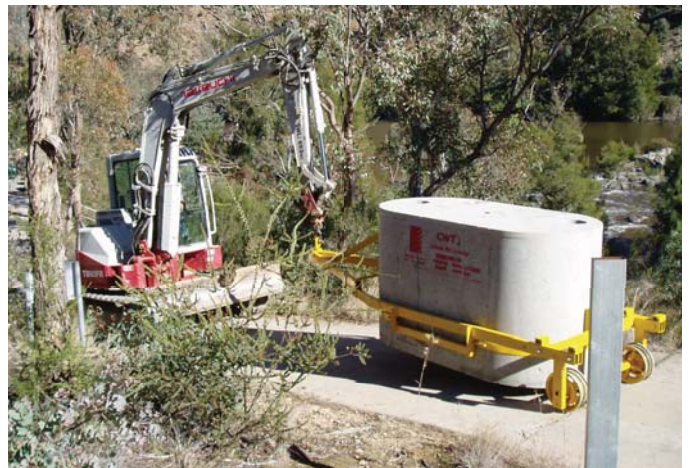
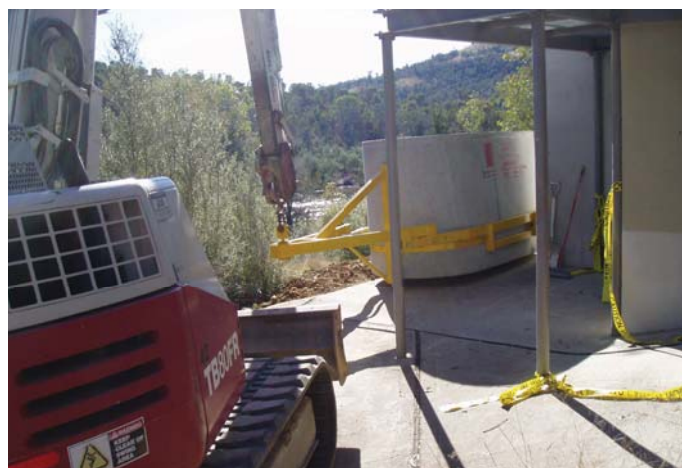
We designed a "wheelbarrow". This was a frame that clamped around the circumference of the collection well. At one end was a set of steel wheels. At the other end, a tow pole with a swivel. The wheelbarrow was to be pushed by a rubber tracked mini excavator. The delivery system worked well. The excavator was able to push the wheelbarrow up the footpath and on to small path in front of the cellar. Then, use it's slewing and travel function, the excavator positioned the collection well partially in to the cellar. At this point the collection wells were chocked, and the wheelbarrow disassembled. Pallet jacks, roller pipes, crowbars and hydraulic jacks and human grunt were then deployed for the final positioning.

The third and last collection well was the most challenging to position. There was minimal clearance between the other two collection wells located on each side of the cellar. Pyramid

building techniques were used ... pipes, levers, ropes, jacks ...even jacking off the concrete cellar roof to tilt the collection well to locate chocks...ancient techniques that worked. The existing passive ventilation system was linked to the collection wells by a PVC manifold. Existing waste plumbing from the sink was connected to one collection well. Down tubes from the pedestals to the collection wells were connected.
